**RADIO SET PRC-F1**  
**'IN-PRODUCTION' CHANGE TO AGC CIRCUIT**  
**MODIFICATION INSTRUCTION**

**RECEIVER-TRANSMITTER RADIO RT-F1**  
**CIRCUIT CHANGE TO IMPROVE 10 KHZ PULSE GENERATOR OPERATION**  
**MODIFICATION INSTRUCTION**

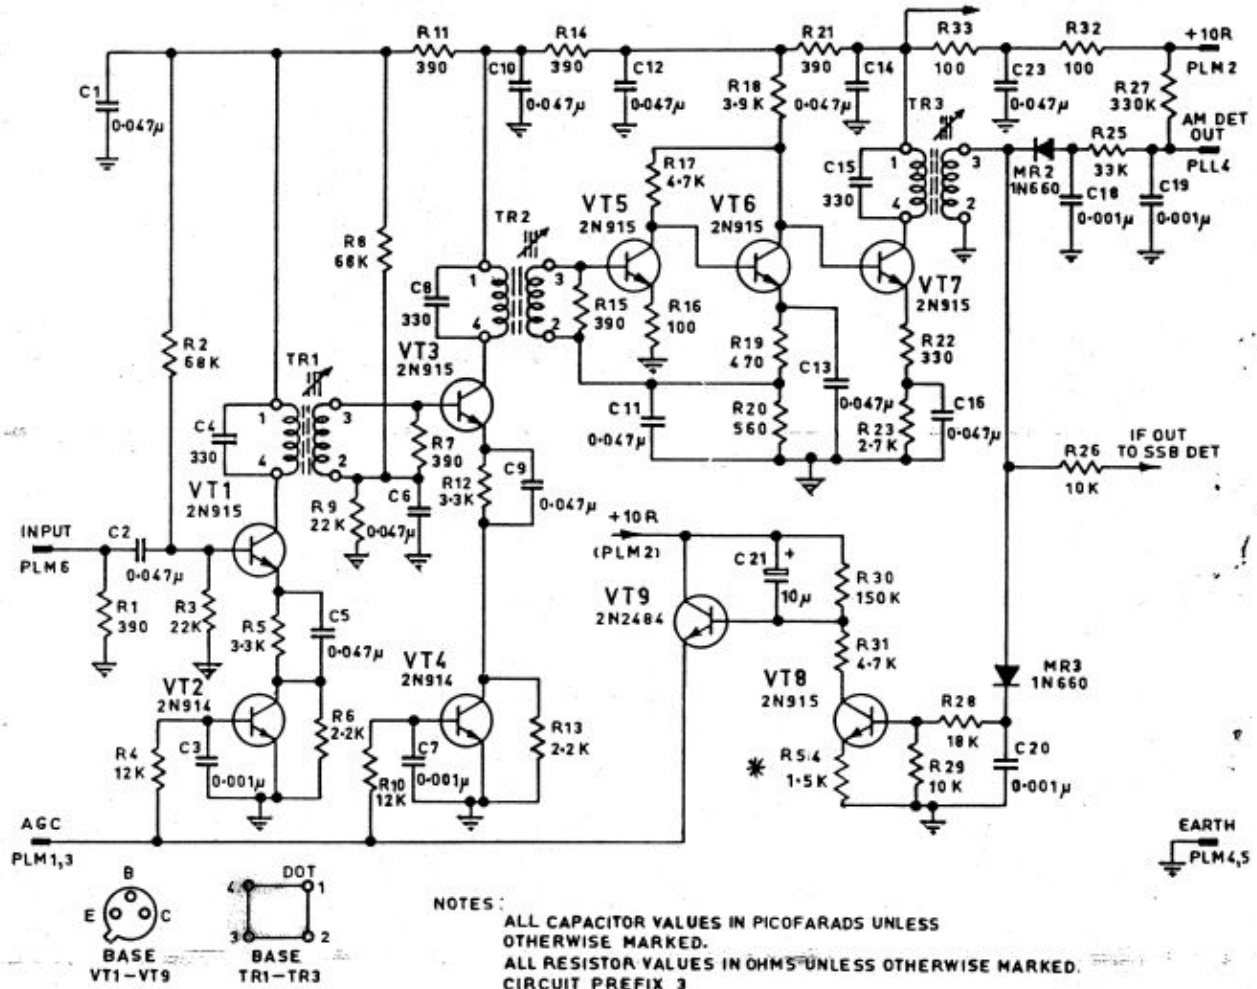
**FIG 1 - IF AMPLIFIER, AGC CIRCUIT AND AM DETECTOR (PART OF 3CB1)**

1. A 'production' modification, applicable to the receiver AGC circuit, has been incorporated in Radio Sets PRC-F1 from Serial No 350 onwards. The modification comprises the fitting of a 1.5 KΩ resistor (R54) in series with the emitter of AGC control transistor VT8 (Receiver IF, AGC, BFO Circuit Card 3CB1) to prevent low frequency flutter at certain levels of receiver input in the NCW mode.

\* Resistor R54 (1.5 KΩ) incorporated in PRC-F1 equipments - serials 350 onwards  
(TSU 141/67)

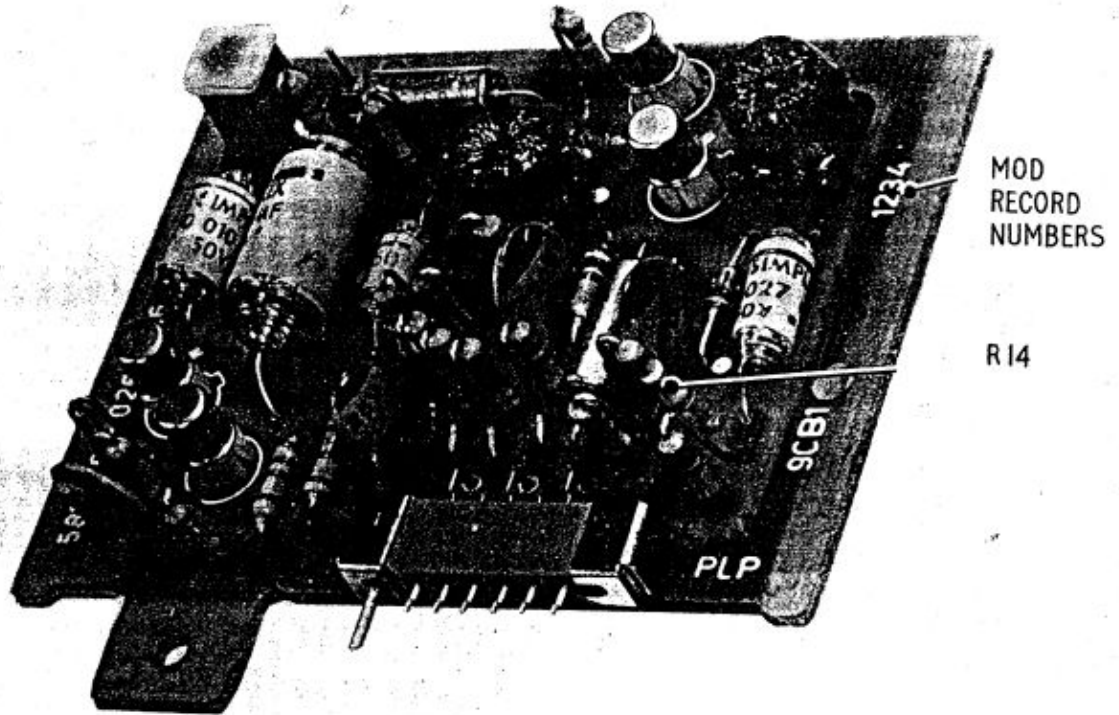
FIG 1 - CIRCUIT BOARD 9CB1 SHOWING POSITION OF RESISTOR R14 AND MODIFICATION RECORD NUMBERS (BEFORE MODIFICATION)

2. The odd 10 KHz malfunction is attributed to the delayed operation of the 10 KHz blocking oscillator VT4-9CB1. The main factors concerned are :
  - a. Resistor R14-9CB1 increases in value and alters the triggering point (emitter bias) of VT4-9CB1.

- b. Differences in pulse amplitude caused by the range of ferrite material used in the manufacture of transformer TR2-9CB1 alters the charge/discharge time of C8-9CB1 and the subsequent triggering point of VT4-9CB1.

3. In general, the output developed under these conditions produce a 6.666 KHz pulse which contains the 20 KHz spectrum but is devoid of 10 KHz points, hence the non-operation of the equipment at the odd 10 KHz frequency selector positions.

4. To compensate for variations in inductance of TR2-9CB1 and provide a suitable triggering time for VT4-9CB1; resistor R14-9CB1 (39 K ohms in existing circuit) is to be replaced with 33 K ohms.

- c. Using the card extracting tool, withdraw Circuit Card 9CB1-10 KHz Pulse Generator (located on the extreme left of the assembly).
  - d. Identify resistor R14-39 K ohms (fig 1) and using a desoldering tool remove the 39 K ohms resistor.

- e. Shape leads of the new 33 K ohms resistor and insert through the board holes, allow for approx 3/32 inch lead protrusion (under the board) on cutting. Bend pigtailed at approx 15° to the underside board surface; solder in position using a miniature iron. DO NOT OVERHEAT BOARD SURFACE AS FOIL DAMAGE MAY RESULT.

12.
  - a. When resistor replacement is complete, carefully scrape away figure 1 stencilled on circuit board 9CB1 (fig 1).
  - b. On the front panel flange modification record plate, strike through figure 2 thus.
